## **Landslides in Trinidad – A Geotechnical Study**

### **Abstract**

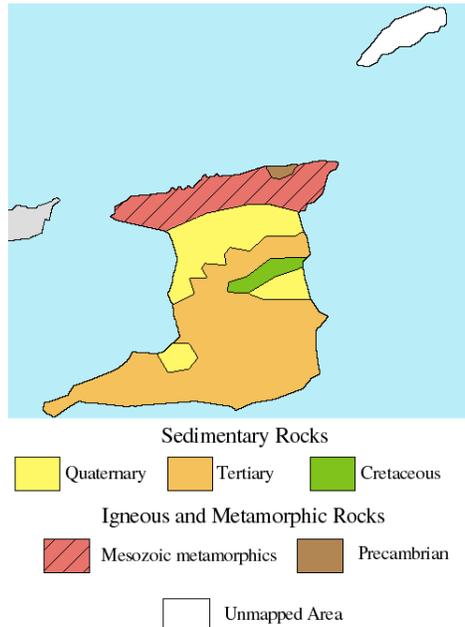
**Fig. 1: The geological map of Trinidad**

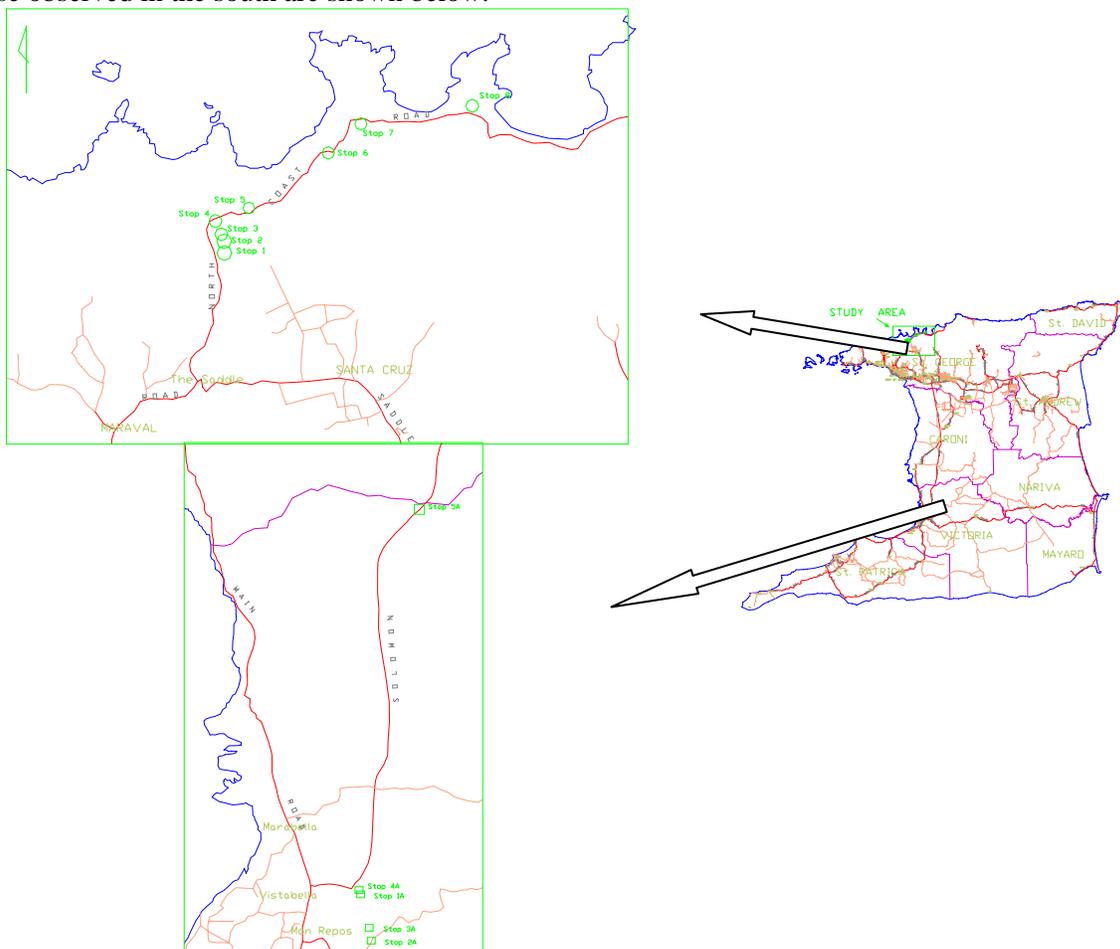
**Fig. 2: Landslide locations in the Northern Range and in the south**

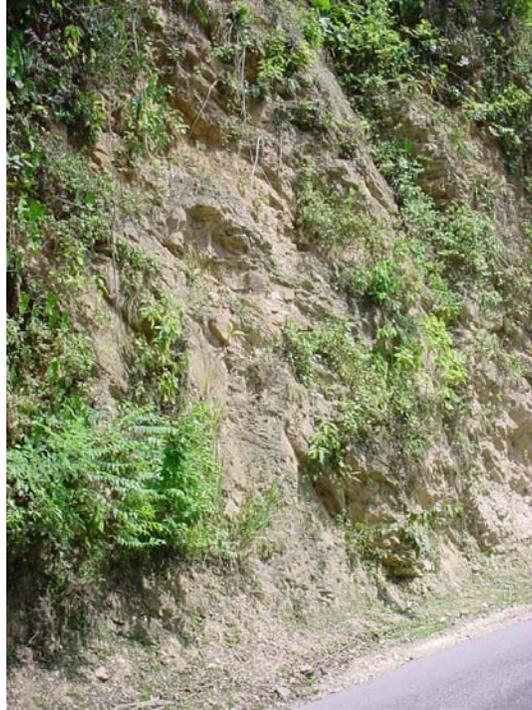
**Fig. 3: Cut vertical face of the forest comprising alternate layers of shales, limestones and phyllites**

The rocks consist of micaceous phyllite alternating with limestone, shale and marls. The rock mass is fragmented by different sets of joints and fractures. The strike direction is N-S. The rocks dip  $45^{\circ}$  due S  $30^{\circ}$  E. Although it is vertical the slope is stable because of its geology.

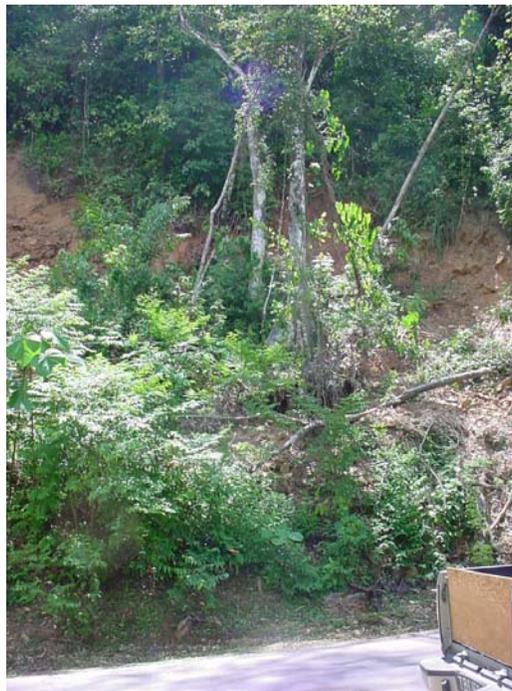
**Fig. 4: Slump: The material has come down vertically with some of the trees standing straight.** One of the slides where the rock mass has vertically come down. The slide has taken place in the talus.

Some of the trees are vertical. Here the slope can be stabilized by a simple retaining wall or gabions.

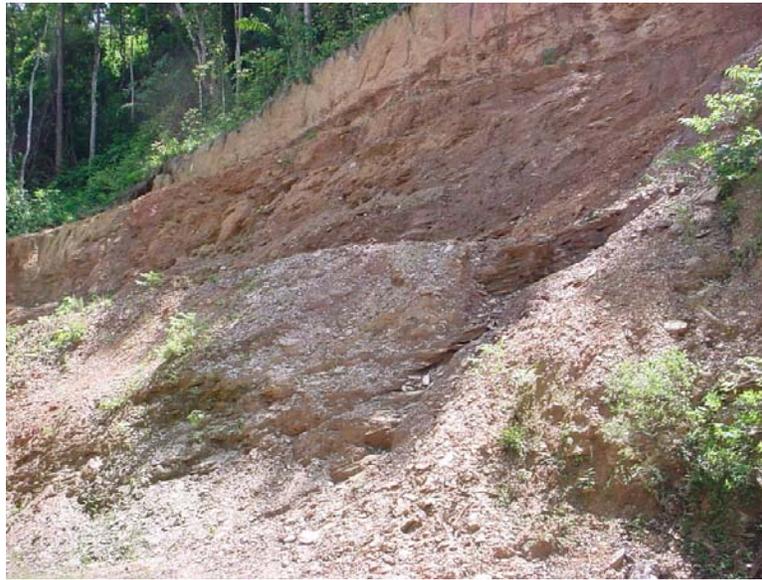
**Fig.5: Scarp in the highly weathered talus on the slope of the green forest. Damage is obvious**

Thick (more than 20m) pile of talus can be seen. The slope is almost vertical. The height of the scarp also is more than 20 meters. It seems it was a stable slope consisting of talus before the slide took place. Unless it is protected, the entire apron of talus with the greenery may run down in the rainy seasons year by year. It has to be protected by covering the entire slope with a wire mesh. And above the slope, a drain perpendicular to the slope has to be developed to prevent run-off over the scarp. If it is not protected, a vast area of the green forest will be lost causing great damage to the environment.

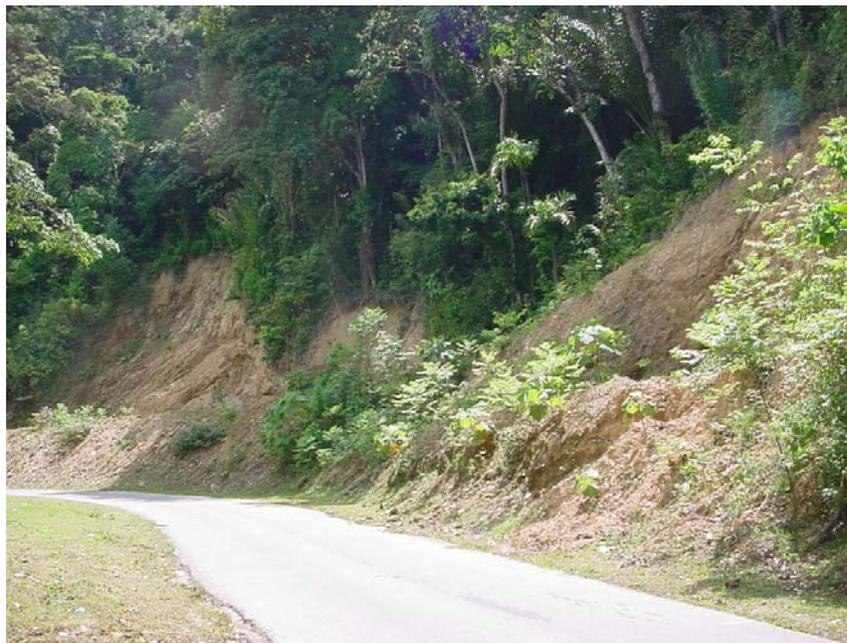
**Fig. 6a: Hill slope consisting of colluvium covered by green trees, getting damaged every year**

Here are two slides with a valley between them. The slide is in the talus consisting of debris of phyllites and other loose materials. They are highly weathered. The slide could have been avoided, had precautionary measures been taken. Besides, wide cracks developed on the other side of the road. The situation here has been shown in the following model.

The road is on steep slopes and there is a possibility of the road being damaged in the future. At a few places, slope erosion on the downstream side of the road is observed. At these sites (figures 6& 7), cracks have developed in the ground on the other side of the road and they are likely to cause damage in future. If care is taken to see that water coming from the hill slope is diverted by a drain as shown in the fig.6b, erosion of the slope can be avoided to a great extent.

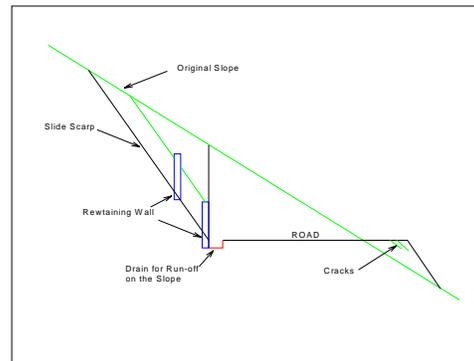
**Fig. 6b: A schematic presentation of the present situation and the protective measures to be taken**

On one side of the road there are slides in the slope. On the other side also two wide cracks have developed and slides may take place in the next rainy seasons.

The steps to be taken here for stability are:

1. A drain has to be developed between the two slides.
2. Another drain has to be built between the road and the slope to prevent run off over the road. This would help prevent slumping and erosion on the other side of the road.
3. The slope face has to be protected by retaining wall supported by buttresses and
4. The slope between the retaining walls has to be terraced.

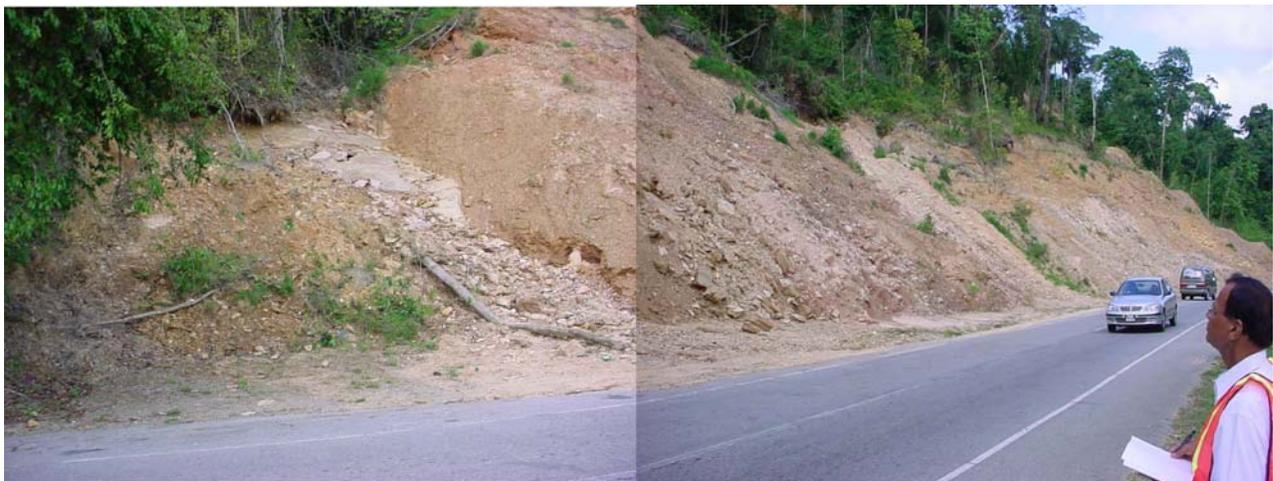
**Fig. 7: Rock-waste along the slope over a vast area. The trees on the left top corner look hanging when the soil cover eroded**

Also, the slope on the other side of the road has developed cracks.

The height of the scarp is about 30 meters. For purpose of study and analysis the area can be viewed as five independent units (fig. 7a). They are: 1. the extreme left slope, 2. the water course, 3. the slope, 4.

another water course and 5. the slope. Slope stabilization has to be taken up considering each one of these as a single unit.

1. The extreme left slope: Water running down the hill slope has totally removed the talus over the slope exposing the bed rock. The soil under the roots of the trees is removed. (The gap between the outcrop and the tree trunk is seen). Here, a retaining wall may be useful for slope stabilization.

2. The water course: there are valleys above the slope. Water collected in the valleys flows down the channel. The run-off has eroded the talus on both sides. This water course has to be developed with a paved channel for free flow of water with protection on both sides.

3. The vertical elevation of this slope is more than 30 meters. This slope has to be terraced with sufficient number of retaining structures along the slope.

4. Another water course: this also has to be developed. And Above this water course, a paved channel perpendicular to this water course minimizes water flow in this drain and reduces erosion.

5. This slope has to be stabilized just as in the case of the previous slope by retaining walls and terraces between them.
6. A small drain existed between the road and the hill slope but it was damaged. Another drain, all along the length, has to be built to avoid run-off flow over the road and the slope below.

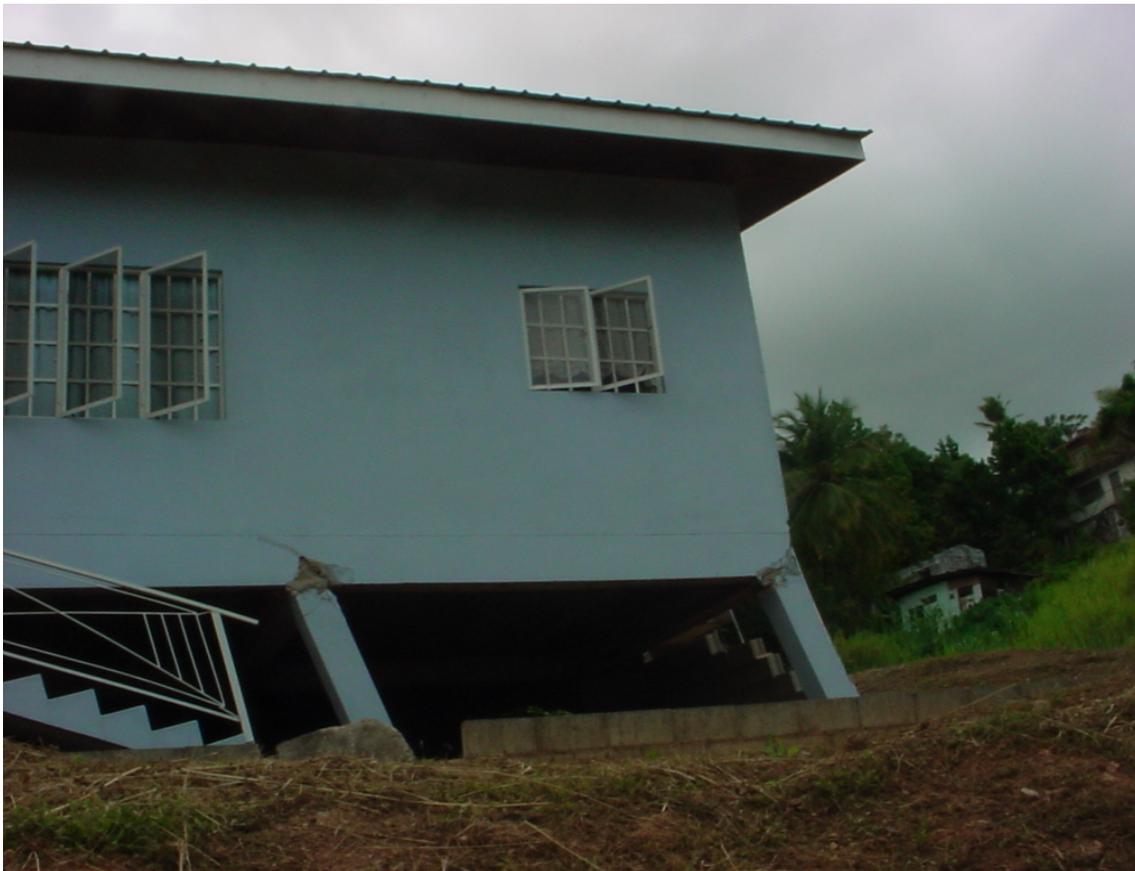
**Fig. 8: One of the houses damaged in the Pashley area, Laventille. The movement of soil below the ground is obviously to the slope to right**

Slides were observed in the Pashley area of Laventille in Port of Spain and along the Naparima – Mayaro Road which involved destabilization of structures existing over the soils. Slides are prone to occur when high plasticity clays alternate with silty clays of medium to high plasticity with varying thickness and plasticity. According to Larsen and Grande (1999) slides might be interpreted with swelling of clay material until failure. The physical properties of materials also control slides. Clay minerals, especially, minerals of montmorillonite group are hydrophylic and swell in the presence of water. Nelson and Tepel (1999) observed that the clay fraction composed of smectite clay minerals in the soils from the landslide surface. Turbulence in the sloping ground by moving vehicles is may be responsible to trigger the slide. Incidentally, all the slides where the structures were damaged are the Pashley area which is crisscrossed by roads and also beside the Naparima - Mayaro Road and the vehicular movement over the road might cause shake to trigger the landslip in the oversaturated mud in the nearby area.

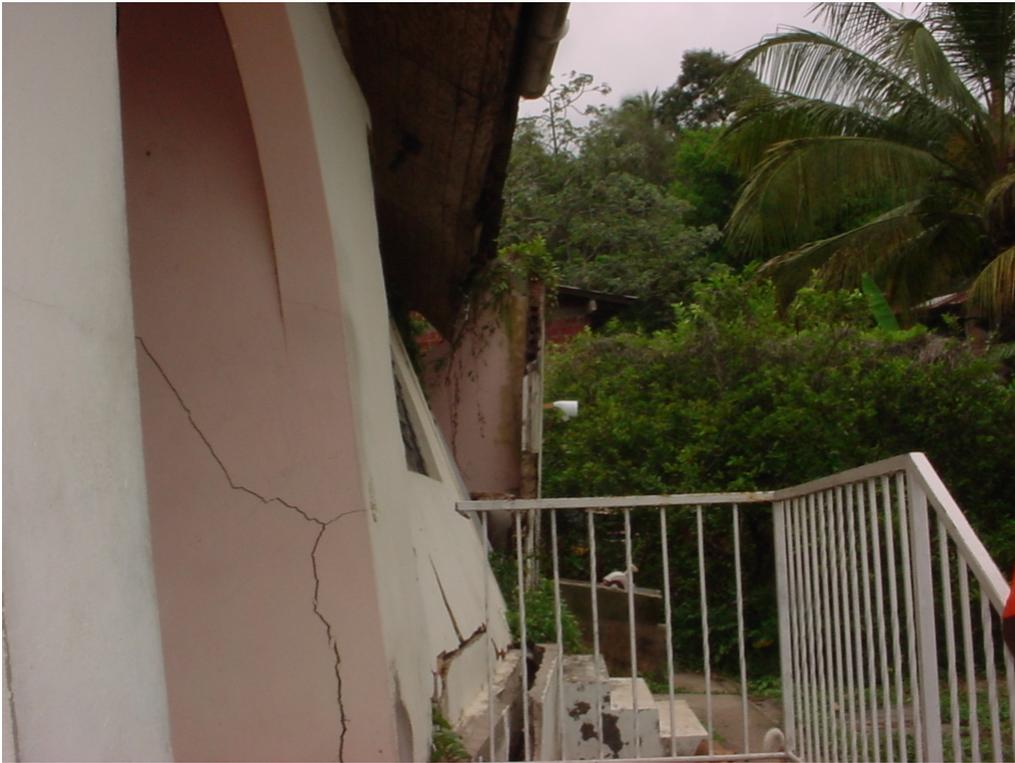
**Fig. 9: another house damaged in the Pashley area, Laventille**

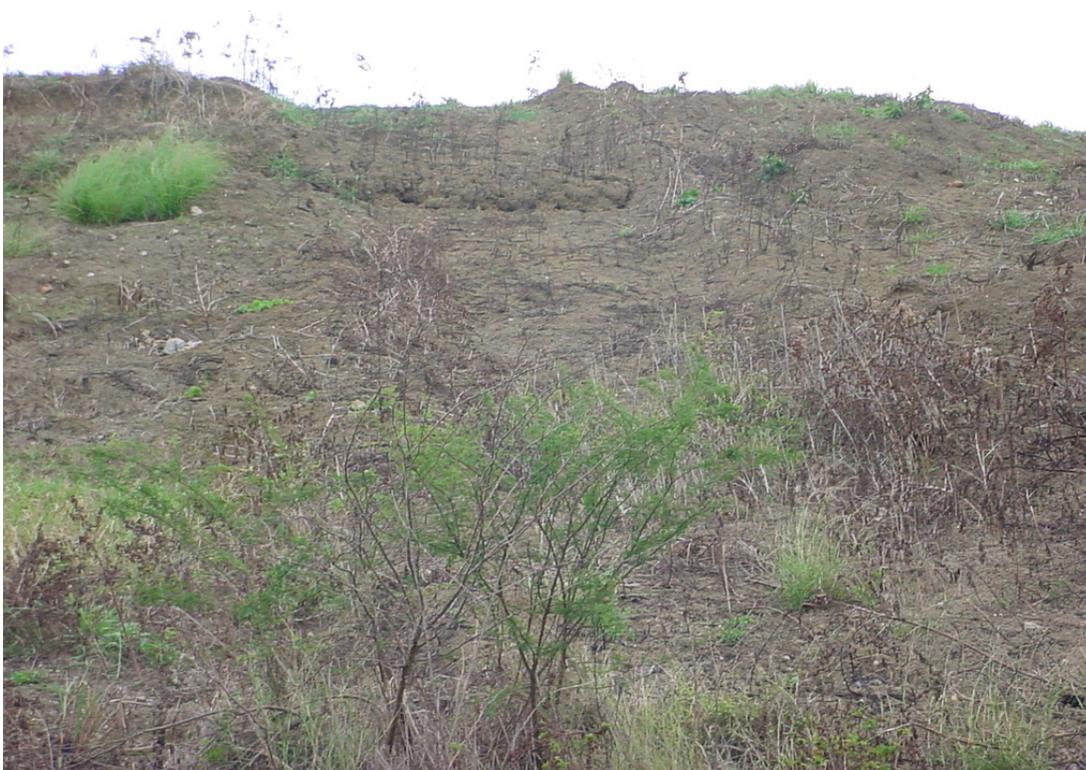
**Fig. 10: The mudslide over the top of the slope. Looks like viscous lava flow. An old slide on the left**

Slides of the second category (figures 8, 9&10) took place in the soils and mud, sometimes of volcanic origin which are becoming viscous when saturated with water and flowing like viscous lava (Fig.10). The slopes in these areas are sometimes hardly 5°. The approach of study as well as addressing the problems in these areas differs.
