## **Strategy for the Rehabilitation of R/C T Beam Bridges with Carbon Fiber Reinforced Polymer Sheets**

Six reinforced concrete T beam bridges have been rehabilitated with Carbon Fiber Reinforced Polymer (CFRP) in flexion and shear in Puerto Rico to improve their load capacity. The economy in initial cost was significant when compared to replacement. These bridges showed heavy flexural and shear cracking of its girders due to overloading and needed posting. As part of the rehabilitation of the mentioned bridges a static load test was performed on bridge 2028 in order to monitor the effectiveness of the CFRP system. Two sets of load test have been performed. Load Test #1 was performed before the girders were rehabilitated on November 21, 2002 and Load Test #2 was performed on August 5, 2005 after the rehabilitation took place. Computer models of the before and after behavior of the bridges were also developed and showed good correlation with the measured displacements and dynamic properties. The load test showed about a 10%-15% increase in stiffness of the bridge. In order to monitor the long term effectiveness of the CFRP rehabilitation system load test will be performed after fi

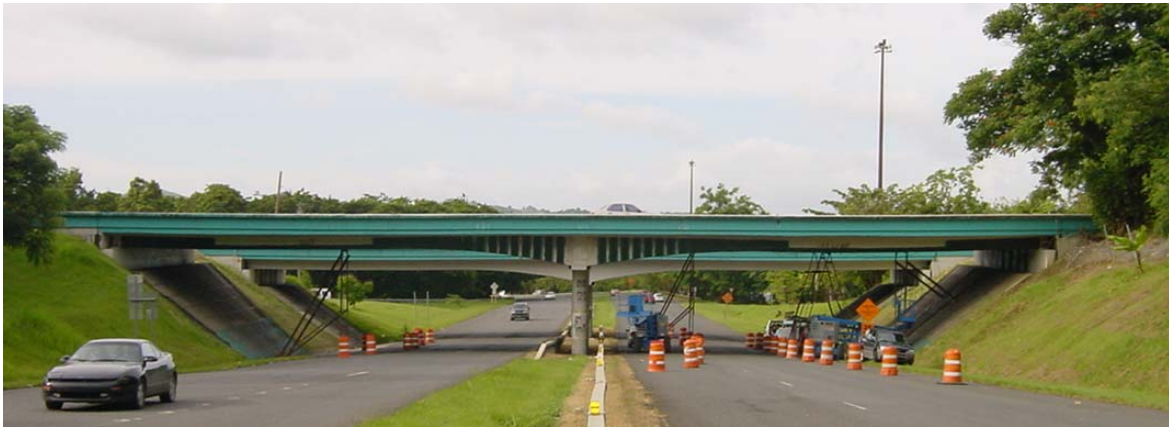
**Figure 1 Bridge 2028 After Rehabilitation with CFRP**

Puerto Rico Bridge #2028 was selected for the long term monitory. This reinforced concrete T beam bridge showed heavy flexural and shear cracking of its girders due to overloading and was a good candidate to be rehabilitated with Carbon Fiber Reinforced Polymer (CFRP) for flexure and shear.

As part of the rehabilitation of the mentioned bridge a static load test and dynamic ambient vibration analysis were performed on the bridge before and after the rehabilitation to record the static and dynamic properties and estimate the effectiveness of the CFRP system. Load Test #1 was performed before the

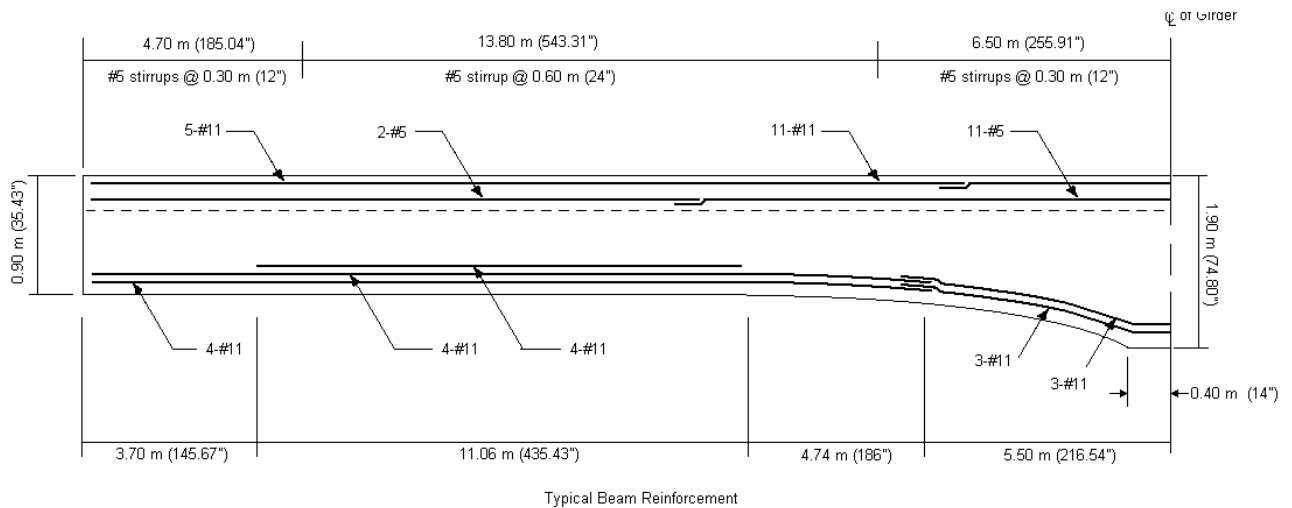
Bridge 2028 has two continuous 25 meter spans with parabolic T beams spaced at 1.73 meters, the web thickness and the slab thickness are 0.40 and 0.18 meters respectively. Figures #2 & #3 show the typical reinforcement schedule and retrofit scheme respectively.

**Figure 2: Typical Beam Reinforcement**

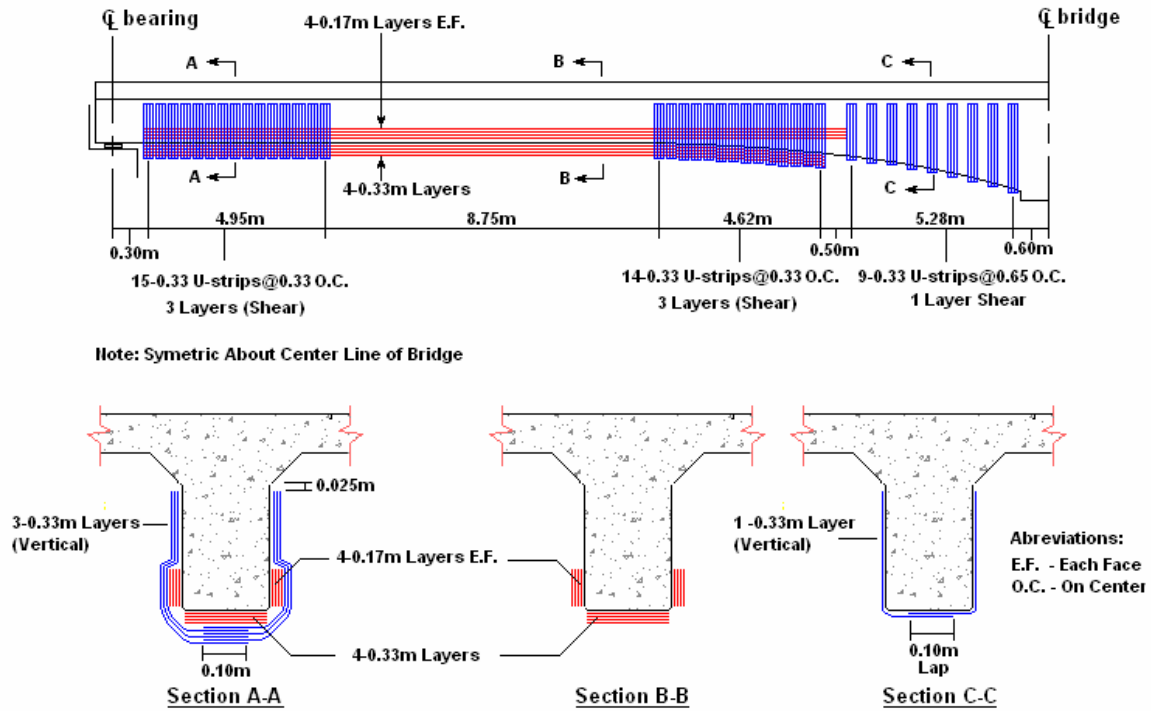
**Figure 3: Rehabilitation of Girders with CFRP**

On the other hand, the capacity at the OPR was adequate for positive moment capacity, but because the bridge showed sings of distress in the positive moment regions it was decided to rehabilitate the bridge for positive moments. The analytical rating of the bridge increased from 0.61 to 0.88 for the HS30-44 live loads at the INV. The CFRP Sheets for shear capacity was increased from a rating of 0.44 to 1.02 at the OPR level for the HS30-44 live load model.

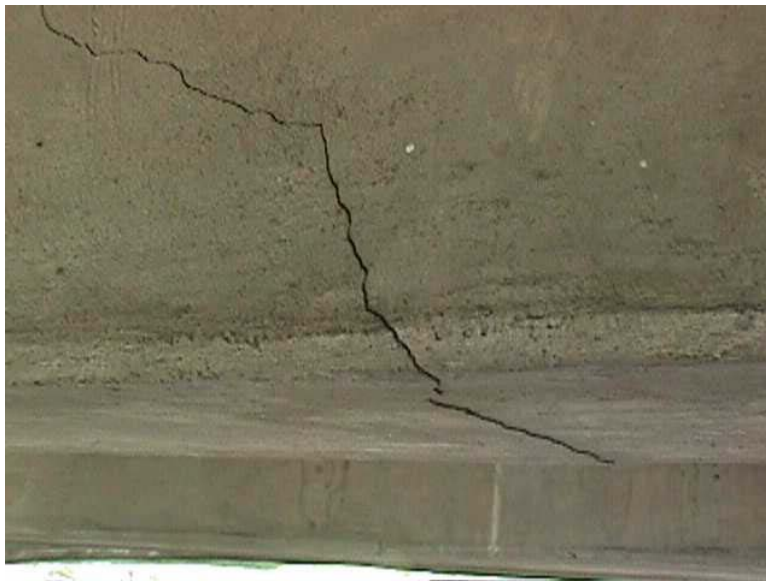
The main reason to do the CFRP rehabilitation on bridge 2028 was because of the heavy flexure and shear cracks present on the bridge girders (see Figure 4) which gave the bridge a poor condition rating. From an analytical standpoint we increased our legal loads up to 110,000 pounds in the year 1997 and thus adopted the HS30-44 live load model for design, so automatically the bridge (designed for HS20-44) was under-designed at the Inventory Level (INV). Analysis shows (see live load envelopes and capacity envelopes in the charts) that even at Operating Level (OPR) the bridge was under-designed. INV and OPR refer to levels of safety for evaluation of structures used by AASHTO [1]. INV is the same level of safety used in design of new structures and OPR is a lower level of safety used when evaluating existing structures. In LFD this translate in a live load factor of 1.67 at INV and 1.00 at OPR.

**Figure 4: Crack in Exterior Girder**

Since the bridge is part of an important route that connects the two main cities in PR (San Juan and Ponce) and was in such bad shape, the alternative of CFRP rehabilitation without having to close the bridge to traffic was selected to improve the condition and increase the rating capacity of the bridge up to the HS30-44 live load. Because CFRP has its limitations in how much it can increase the section capacity, the HS30-44 live loads at the OPR level was accepted as suffice for the rehabilitation design, although the effort was made to increase the capacity to HS30-44 loads at the INV level.

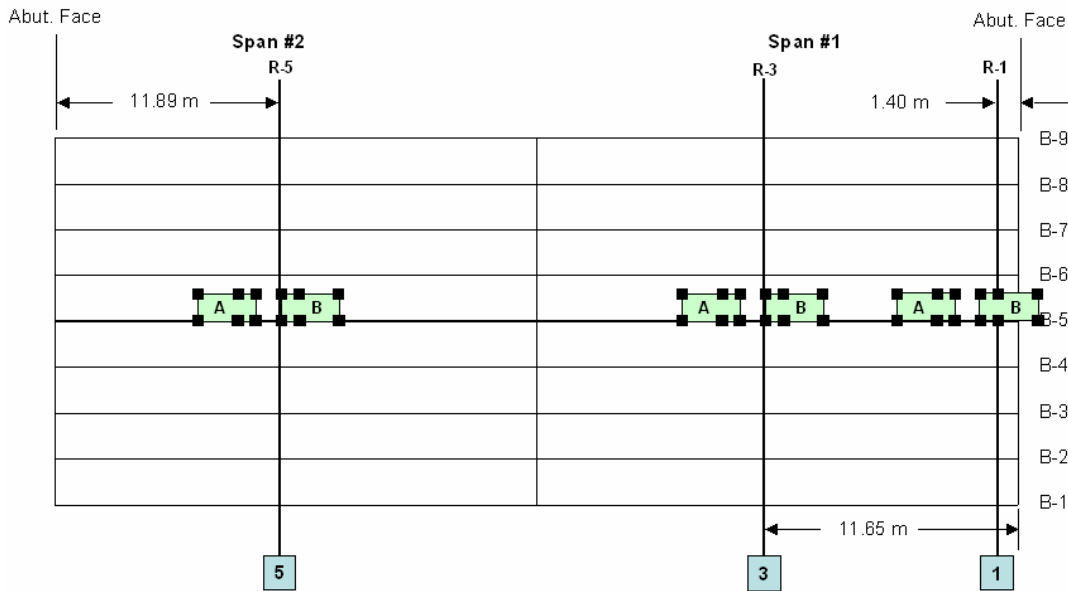
The load consisted of two dump trucks for a total weight of 171 kips on the first test and 150 kips on the second test. The loads were placed at eleven different locations on the bridge. The gauges were placed on the bridge strategically so there would be gauges at the points of maximum strains and displacement for each of the load cases. In all, the eleven load cases should give an overall record of how the bridge was behaving before and after the rehabilitation. Figure #6 show the truck positions for three load cases.

**Figure 6: Truck Locations for Load Cases #1, #3 & #5**
