# **Tropical Storm Impact on Infrastructure: A Case Study of Noel in the Dominican Republic**

A commission consisting of faculty from the University of Puerto Rico at Mayagüez and Universidad Autónoma de Santo Domingo visited the Dominican Republic to evaluate the disaster caused by the Tropical Storm Noel, that took place from October 26<sup>th</sup> to 31<sup>st</sup> 2007. Students also participated to have practical experience as part of their learning. This was the most intense tropical depression with extreme winds and torrential rainfall that hit Dominican Republic in 2007. This paper presents the findings and lessons learned from the consequences of the storm on three main aspects: the hydrology and hydraulic behavior of the system, the effect on the transportation infrastructure, and the impact on civil infrastructure. In addition, it mentions the disaster implications on the affected population in the visited areas.

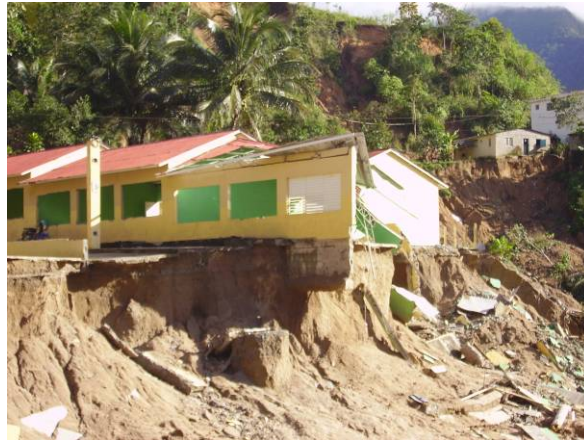
**Figure 2: River Impact on the Mariano Garabito School**

Los Cacaos suffered in several important aspects from this tropical storm. First, landslides occurred alongside most of the rural highway that connects the community with the rest of the province; secondly, the obstruction of the closest bridge to the village (both situations caused this town to be isolated from the help provided by the emergency response centers); scouring of the river banks downstream from town; thirdly, the destruction of the drinking water distribution system; fourthly, the destruction of the local school “Liceo Nocturno Mariano Garabito” shown on Figure 2 (one of the best constructed structures in town for its apparent structural integrity), located in the left bank downstream of the main obstructed bridge; and lastly, imminent state of emergency due to the unstable slopes threatening the community to be impacted by landslides and debris flow from nearby mountain. The area was isolated from their neighbors for several days because various sections of the access road were severely damaged or destroyed.

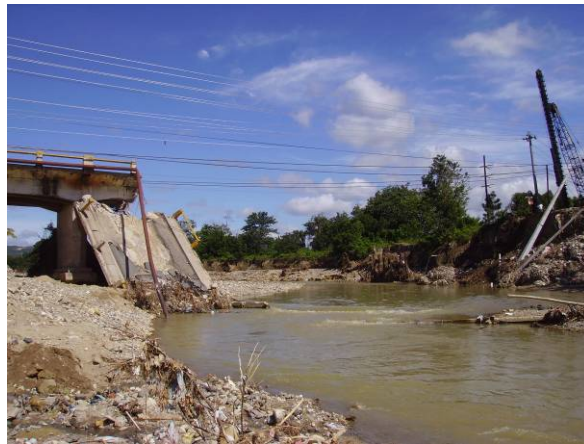
**Figure 3: Damages to Madre Vieja Bridge.**

The Madre Vieja Bridge is located in the province of San Cristóbal, south of Monseñor Nouel. This was one of many bridges that suffered severe damages due to the effects of flood forces in the area. What makes this case special is the extent of damage suffered. The force of the river caused so much erosion and scouring that two spans of the bridge completely collapsed (see Figure 3).

The bridge failure was triggered by erosion and scouring of the left abutment, which was flushed away. The extent of the scouring around and below the left abutment looking downstream with the water current helped the abutment to overturn in the direction of the largest scouring depression. A similar mechanism most probably occurred with the bridge piers supporting the two spans that collapsed. Over 30 feet of embankment was eroded far behind of the bridge abutment. It was observed that highly populated communities along the river banks were under the flood levels. It is of extreme concern that a whole community was living under adverse conditions under the bridge on the floodway. It was obvious the social and infrastructure weaknesses of the community. This community was completely flooded during the tropical storm, lost all their scarce belongings and had very difficult moments during the disaster and its aftermath. The social, economic, and sanitary conditions in which Noel left them were deplorable.

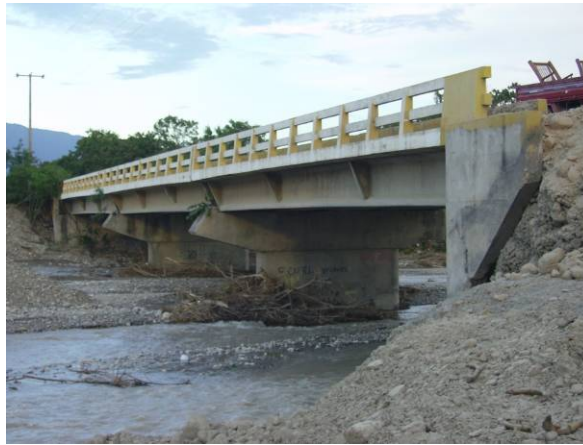
**Figure 4: Los Jovillos Bridge**

- **Bridge Los Jovillos in Azua over the Los Jovillos River (Figure 4):** Azua is located in the Southern part of the Dominican Republic and is known for being an arid province with a great extent of low level land forming a large flood plain. The water level rose above the bridge structure and the embankment of one of the approach structures was washed away. The structure of the bridge showed apparent lack of capacity due to either insufficient hydraulic conveyance or by debris obstruction during the flood. The evidence of the size of sediment's load transported, from fine to coarse (including cobbles), was impressive. This impressive size was probably due to two things: first the magnitudes of flood discharge; and secondly the high velocities capable of transporting stones of 2' to 3' in diameter.

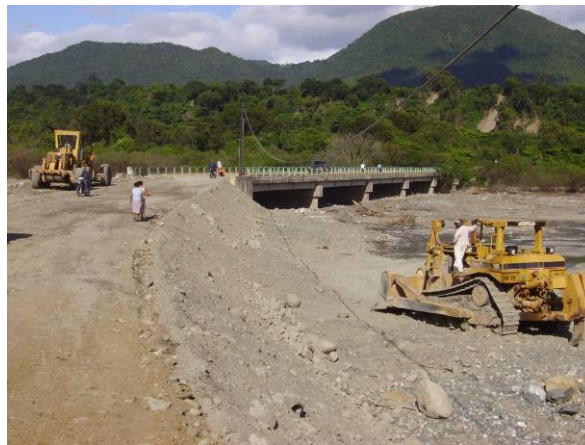
**Figure 5: Reconstruction of San José de Ocoa Bridge**

- **Bridge San José de Ocoa:** This situation was similar to Los Jovillos Bridge in Azua. The evidence showed overtopping, huge sediment loads obstructing the bridge openings, and tremendous levels of erosion and scouring. The left approach embankment between the bridge and the road was flushed away for a distance of over 100 meters. This bridge was under the process of restoration by reconstructing a similar embankment and removing the sediments deposited upstream, downstream, and under the bridge. The bridge structure proved to be structurally resistant to the event. In the rehabilitation an upgrade of the bridge hydraulic capacity by clearing the bridge opening from sediments was observed.

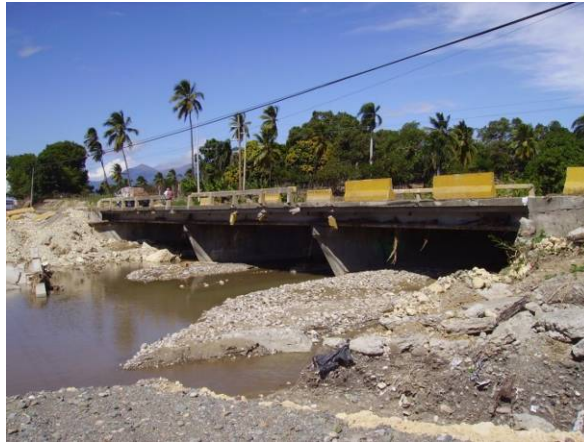
**Figure 6: Paya River Bridge**

- **Bridge over Paya River on Sanchez Highway (Figure 6):** This road connects Santo Domingo with Baní (at Province of Peravia, between Azua and San Cristóbal) in the South Region of the Dominican Republic. The most relevant finding was that the sediment load was so large that mountains of gravel and cobbles were deposited upstream, under, and downstream of the bridge impeding the water to flow freely and causing overtopping. The structure integrity of the bridge was conserved but some surface damages were observed to the bridge platform.

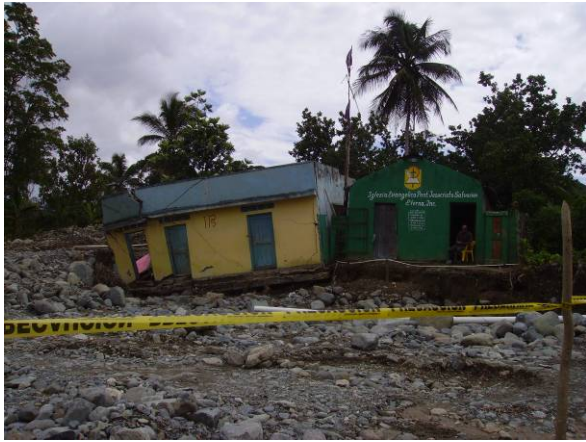
**Figure 7: Remains of Las Cuevas Community**

- Significant geomorphologic river modifications, including the channel diversion and relocation, huge embankment erosion and deposition, and change of the river local reach slopes and cross section.
- Flushing of a housing community alongside the river (Las Cuevas, see Figure 7), which accounted for over 150 deaths (most probably over 200 because of inaccurate population census in the area).
- Severe damages to the water supply dam, intake, pumping house, and water transportation system (foot & water main) to the potable water treatment plant.
