COST-EFFECTIVE REPAIRS OF MARINE CORROSION DAMAGE

ABSTRACT

The selection of materials for corrosion damaged concrete repairs is more difficult than for new construction. The range of materials used is broader than just cementitious materials, because many polymeric compositions can be used effectively for concrete repair. Frequently, the period in which the structure can be brought back into service, the accessibility, and the position of the repair in relation to the level of the tide are also important considerations in the selection of materials and methods for repair.

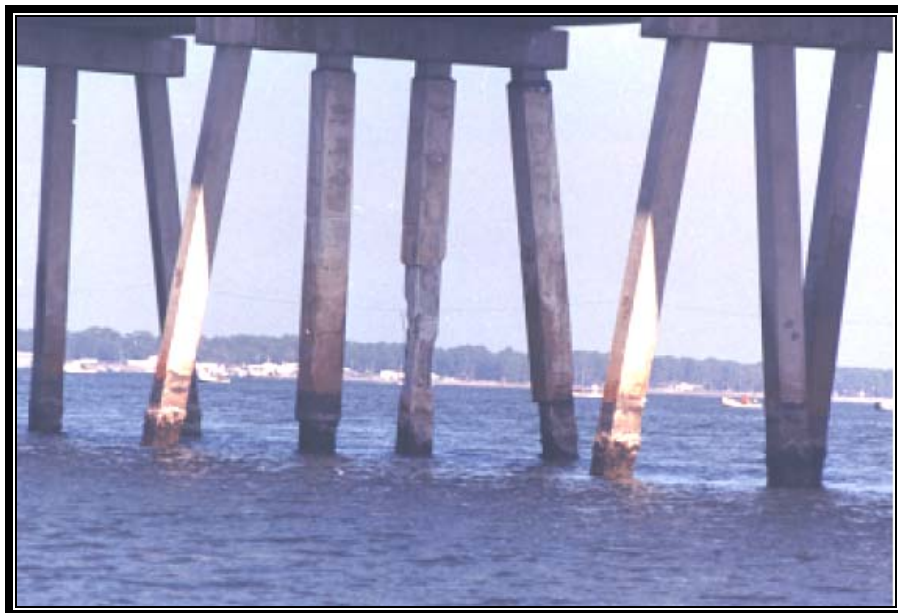
Figure 1: One of the Bryant Patton Bridges Displaying Reinforced Concrete Piles with Significant Corrosion Induced Damage - Florida (reproduced from Concorr, Inc).

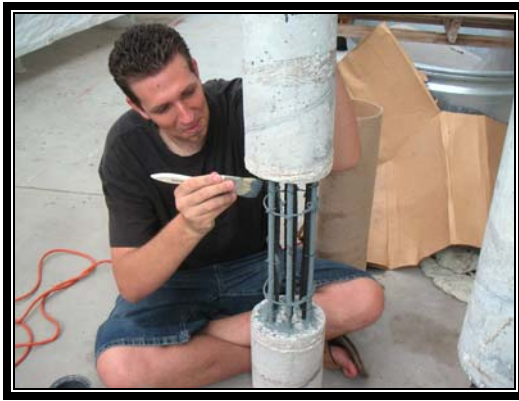
Figure 6: Reinforcement coating with rebar primer

After the steel reinforcement was coated, it was spliced with the FRP reinforcement, Fig. 6. This was achieved by simply cutting the FRP bars to an equal length of the exposed steel reinforcement, and attaching the FRP reinforcement to the steel using wire ties. The ties were also coated with the zincrich rebar primer, Fig 7.

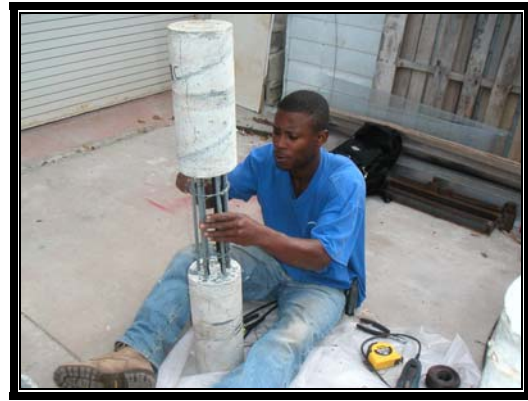
Figure 7: FRP Splicing of cylinders

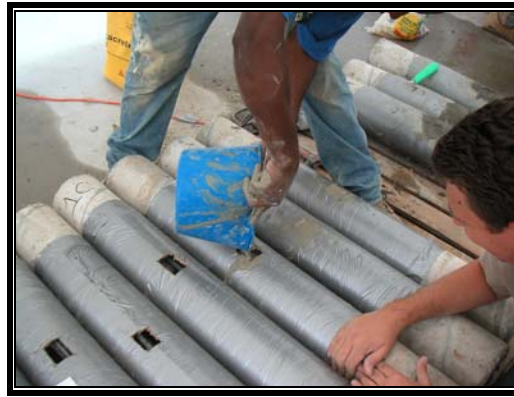
Figure 9: Mix Pouring for Repair 2

Sika 211, which consists of prepacked aggregate and cement, was used in this mix, along with sand, water, and lime. The proportions were as follows: 1:2.65 water to binder and 1:1.25 binder to sand, with the binder including the aggregate. Lime was added at 10% by volume of Sika 211. Fig. 9 shows the pouring process for the specimens.

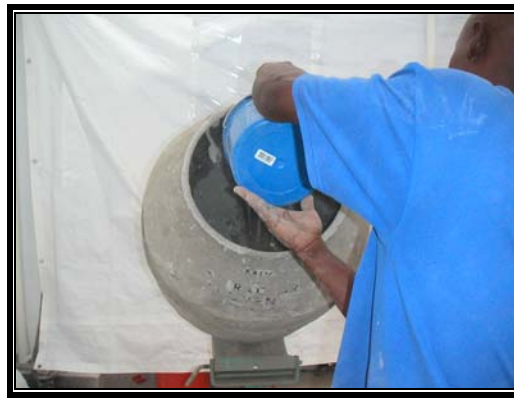
Figure 11: Repair 3 – Mix Preparation

This mix consisted of Type I and Type II Portland cement, sand, Florida Pearock Aggregate, water, and silica fume with proportions of 1:1.6 water to binder, 1:2.2:2.5 (binder:sand:aggregate). Silica fume was added as replacement of 8.5% by weight of cement, as shown in Fig 11.

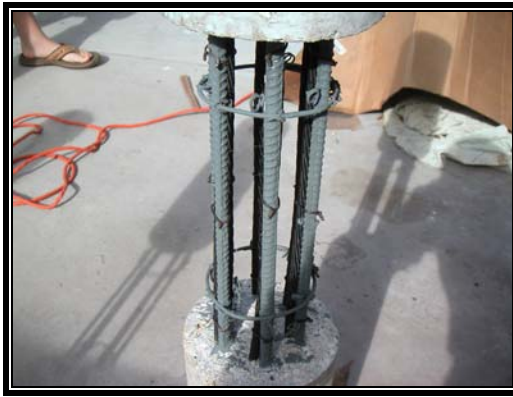
Figure 13: Specimen Spliced with FRP

FRP reinforcement was spliced with the steel reinforcement with the same procedure as Repair 1 before placement of the forms. The concrete mix consisted of Type I and Type II Portland Cement, sand, Florida Pearock aggregate, water, and gypsum, Fig. 13.

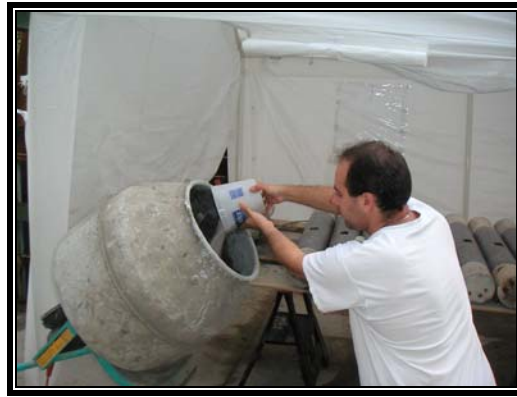
Figure 14. Repair 4 – Mix Preparation

The proportions were as follows: 1:1.25 water to binder, 1:1.4:1.28 (binder:sand:aggregate). Gypsum was added at 10% by weight of cement to facilitate the build-up of thick layers. The amounts used in repairs for each cylinder are shown in Table 4.

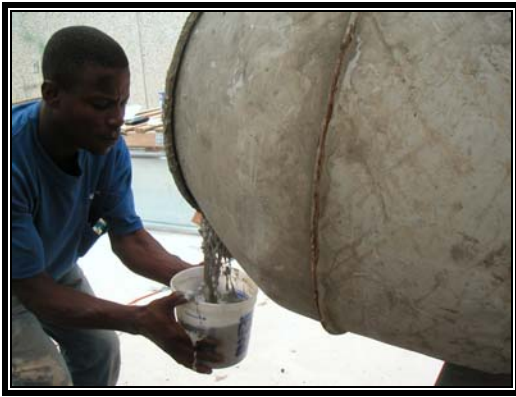
Figure 16: Repair 5 Mix Preparation

Repair 5 included using Type I Portland Cement, superplasticizers, Florida Pearrock aggregate, sand, silica fume, fly ash, water, and polyolefin fibers. The water to binder ratio was 1:2.88, with silica fume and fly ash each contributing 6.5% to the binder (cementitious mix). The remaining proportions were as follows: 1:1.22:1.09 (binder:sand:aggregate). Polyolefin fibers were added at 1.5% by volume and the superplasticizer at 2% by weight of cement.

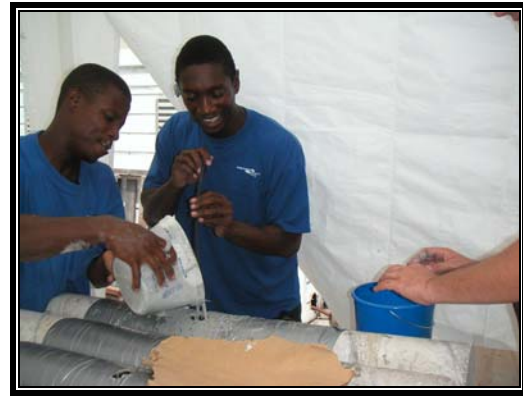
Figure 17: Repair 5 – Mix Pouring

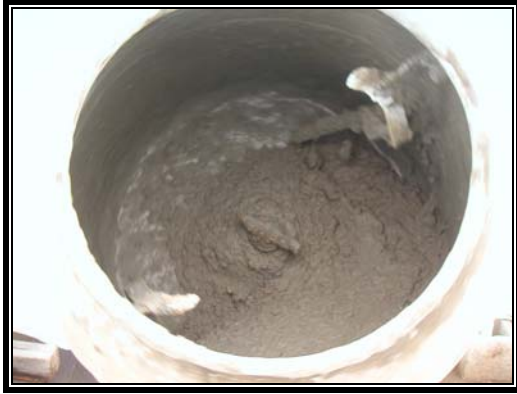
Figure 19: Repair 6 – Mix Appearance

This mix consists of using Sika 211 with prepacked aggregate and the Sika Latex R as the styrene-butadiene latex mortar. Water, Sand, and Lime were also included in the mix. The water to Sika 211 ratio was 1:2.27, and the Sika 211 to sand ratio 1:1.25 (binder:sand, with the binder including the aggregate). The Sika Latex R was mixed at 10% by weight of Sika 211. Lime was added at only 5% by volume of Sika 211.

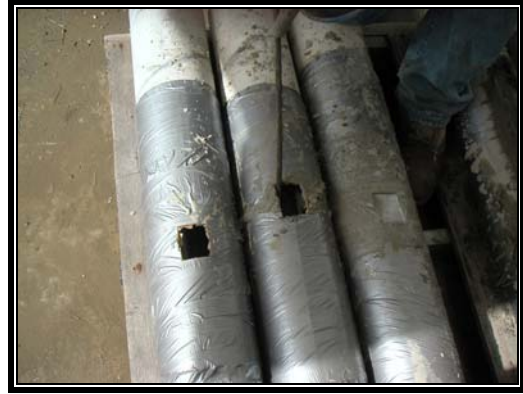
Figure 20: Repair 6 – Mix Pouring
