Toward an inventory and vulnerability of aboveground storage tanks in Puerto Rico

Research on the buckling behavior of thin walled metal tanks used in the oil industry has been performed at the Civil Infrastructure Research Center of the University of Puerto Rico for almost 10 years. However, the mechanics of behavior is only part of the complete picture and to address the impact of hurricanes or earthquakes on the oil industry it is necessary to have an inventory of tanks in Puerto Rico, which is the subject of this paper. This research has been done using data from aerial photographs supplemented by site visits. The information obtained are the diameter, height and the type of roof. This limited data is very useful because the design of tanks is regulated by American Petroleum Institute codes and follows rather standard geometric patterns. A vulnerability assessment of a typical existing tank is presented. It was found that this tank would not be able to sustain the current seismic and hurricane wind demand from actual codes. It is suggested that the information obtained from this study can be used to construct fragility curves for tanks.

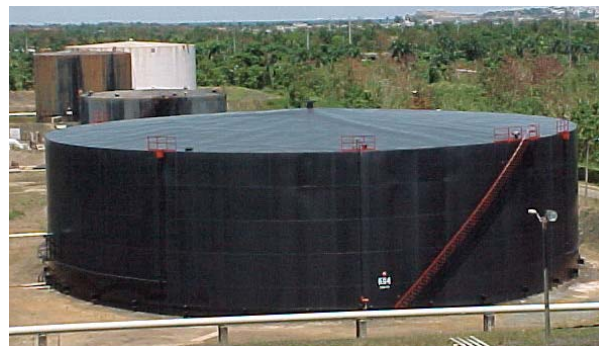
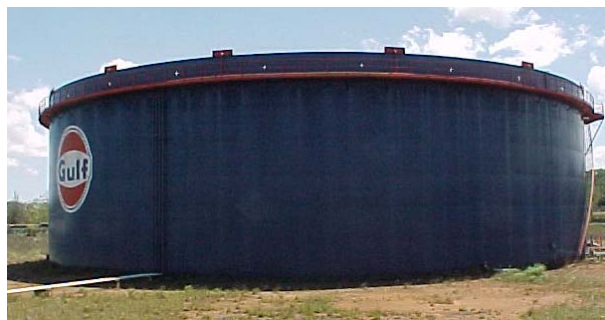
Figure 1 - Typical tank geometries in Puerto Rico; (a) Tank with cone roof, (b) Tank with floating roof

The important features of the tanks, such as roof systems (either floating roof or fixed roof), diameter length, aspect ratios (cylinder height/diameter ratio) were considered in the survey. The survey was conducted using aerial photographs, from which only two geometric parameters could be identified: the type of roof (classified as fixed roof or floating roof); and the diameter of the tank. Notice that the roof type (e.g. cone, flat or dome roof) is not included in the survey, since they can not be distinguished from just aerial photographs. Typical tanks with cone and floating roofs are illustrated in Figure 1. Notice that the height of the cylinder can not be identify from the aerial photographs; however, a triangulation was made with lateral photographs (such as those in Figure 1) which were obtained during the site visits (Virella 2004).

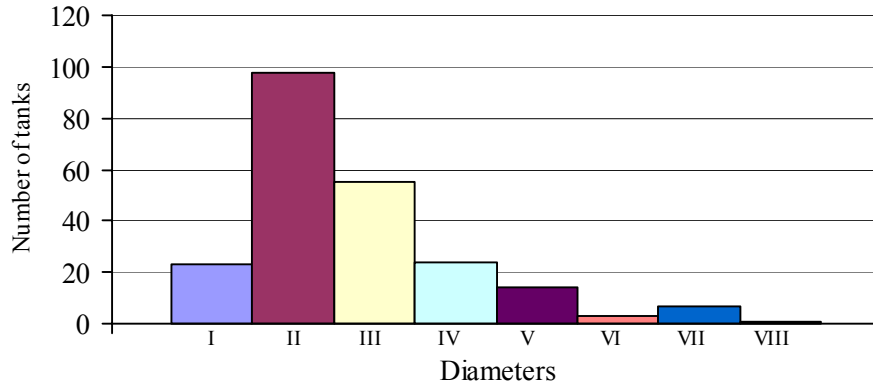
Figure 2 - Total number of tanks with fixed roofs within each diameter group

The numbers of tanks within each group are illustrated in Figures 2 and 3 for tanks with fixed and floating roofs. For the tanks with fixed roofs most of the tanks fall within groups II (43.6%) and III (24.4%), so that most tanks with fixed roofs have diameters in the range of 10m and 30m. For the tanks with floating roofs shown in Figure 3, the largest number of tanks fall within group II (32.9%), followed by groups III and V with 15.9 % of the total. The dominant single diameters for the tanks with floating roofs are the same obtained for the tank with fixed roofs ($10\text{m} \leq D \leq 50\text{m}$). For the combine fixed and floating roof tanks (Figure 4), the dominant diameter falls within group II; i.e. about 41% of the tanks have diameters in the range of 10m and 20m.

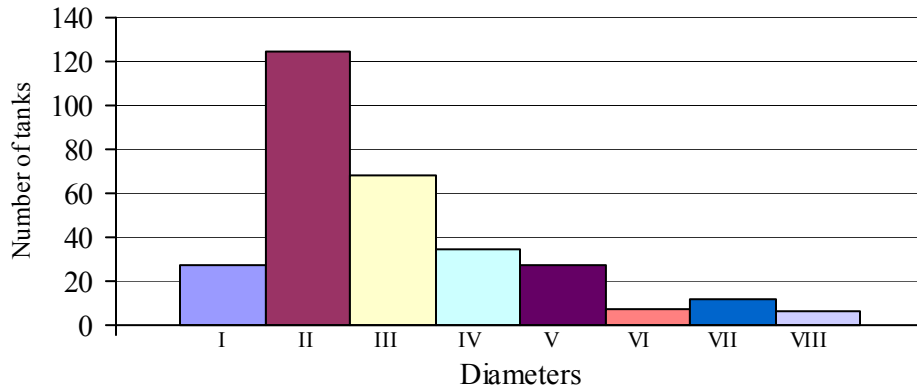
Figure 4 -Total number of tanks within each diameter group

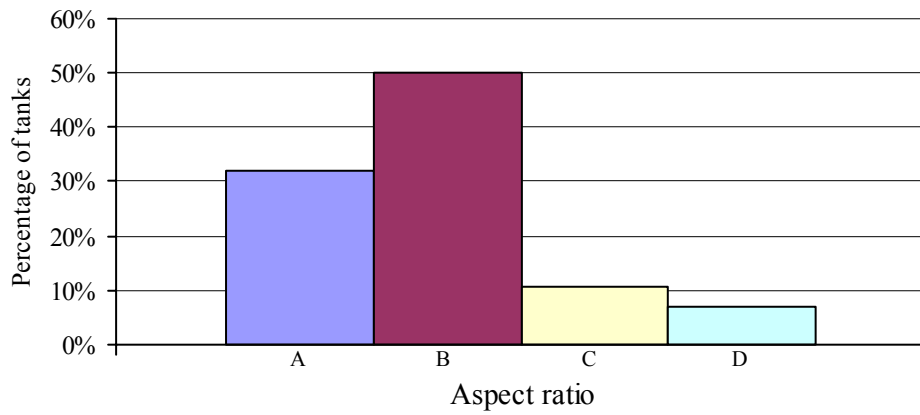
Figure 5 -Total number of tanks within each aspect ratio group.

Figure 5 illustrates that most of the tanks fall within groups II (50%) and III (32.1%) accounting in combination for a total of 82.1% of the total tanks in the sample. Thus, it may be concluded that the majority of the tanks have aspect ratios in the range of 0.40 and 0.60 (Group II).

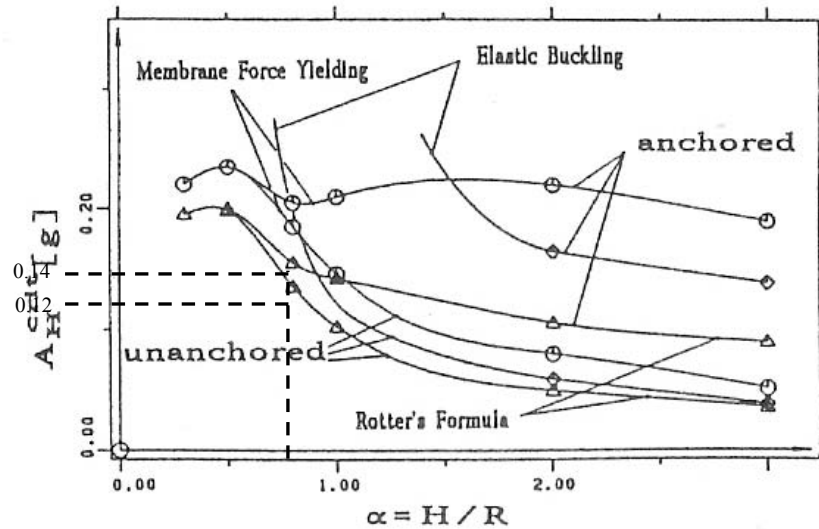
Figure 7 - Vulnerability curves of steel cylindrical tanks subjected to earthquakes (Reproduced from Rammerstorfer et al. 1990).

In this section the seismic vulnerability of tanks with the typical geometries obtained from the survey is evaluated. Typical vulnerability curves for different failure modes of the tank subjected to earthquakes are used for the evaluation. These curves were obtained from Rammersorfer et al. (1990), based on results of Fischer et al. (1990), in which static analyses of anchored and unanchored tanks were performed and the critical horizontal acceleration that induces different modes of tank wall instability was found. These curves are presented in the form of critical horizontal acceleration (a_h^{crit}) versus cylinder height to radius ratio of the tank ($\alpha = H/R$).

For the seismic vulnerability evaluation, the tank with cone roof of Figure 6 is selected, which has $H/D = 0.50$, or $\alpha = 1.0$. The following values of a_h^{crit} are obtained from Figure 7 for this geometry:

- Failure mode: Elastic buckling, $a_h^{crit} = 0.12g$.
- Failure mode: Membrane yielding, $a_h^{crit} = 0.14g$.

These results mean that a typical tank would initially fail by elastic buckling and would probably have membrane yielding as a post-buckling effect. Notice that the a_h^{crit} of $0.12g$, which induces buckling in the tank shell, is a lower horizontal acceleration than most actual design codes specified for Puerto Rico. For example, in the case of rock conditions at the base, a PGA of $0.30g$ is specified in the UBC (1997) code for Puerto Rico. In that case for the design earthquake considered in the actual design codes (i.e. with a recurrence interval of 475 years), the typical tank is expected to fail and will probably have serious damage.

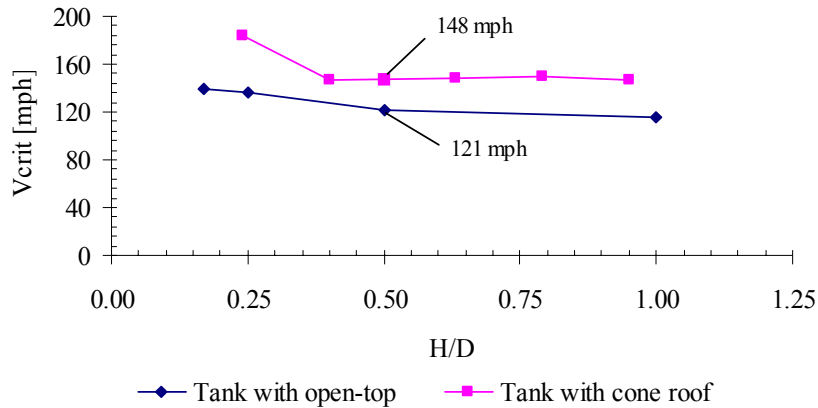
Figure 8 - Critical wind speed for tanks with different H/D ratios.

The most representative dimensions of the tanks in Puerto Rico corresponds to a diameter of 15m and a ratio H/D = 0.5. From Figure 8, this geometric configuration buckles at a critical wind speed of 148mph for the tank with cone roof and 121mph for the open-top tank. The tank with cone roof has a critical velocity which is close to the design wind speed for Puerto Rico (145mph at 10m height from ground), as established by ASCE 7 (2005). The case of the open-top tank is even more critical because the velocity is very close to the sustained winds during hurricane Georges (120mph). These values do not account for other effects that reduce the critical wind velocity of the tanks, such as imperfections in the shell.

The authors thank former graduate student Luis Serrano, who started the survey of tanks reported in this paper, and Dr. Eduardo M. Sosa, who performed the wind computation loadings to Figure 8.
